DEPARTMENT OF NATIONAL DEFENCE

ENVIRONMENTAL DISCLOSURE REPORT

DUNROBIN ANTENNAE YARD

JULY 1995

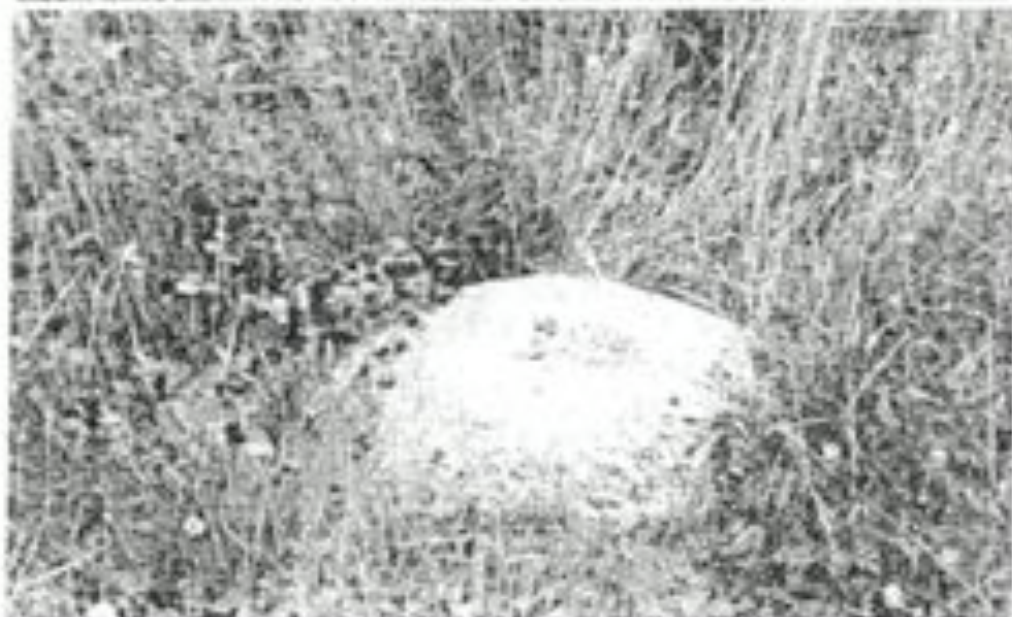
Bottom - Photo 2. Concrete and steel anchoring point with the steel cut down to the concrete. (Photo taken 24 July 95).

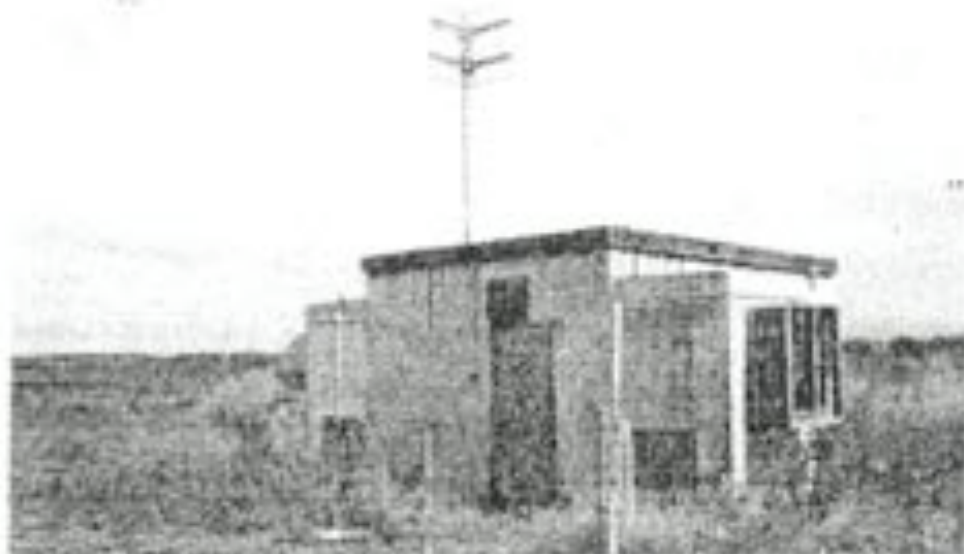
Top - Photo 3. A photo of the exterior of the one building on site. No contaminants exist surrounding the building. The underground fuel tank was removed 6 Oct 1994 (Photo taken 24 July 95).

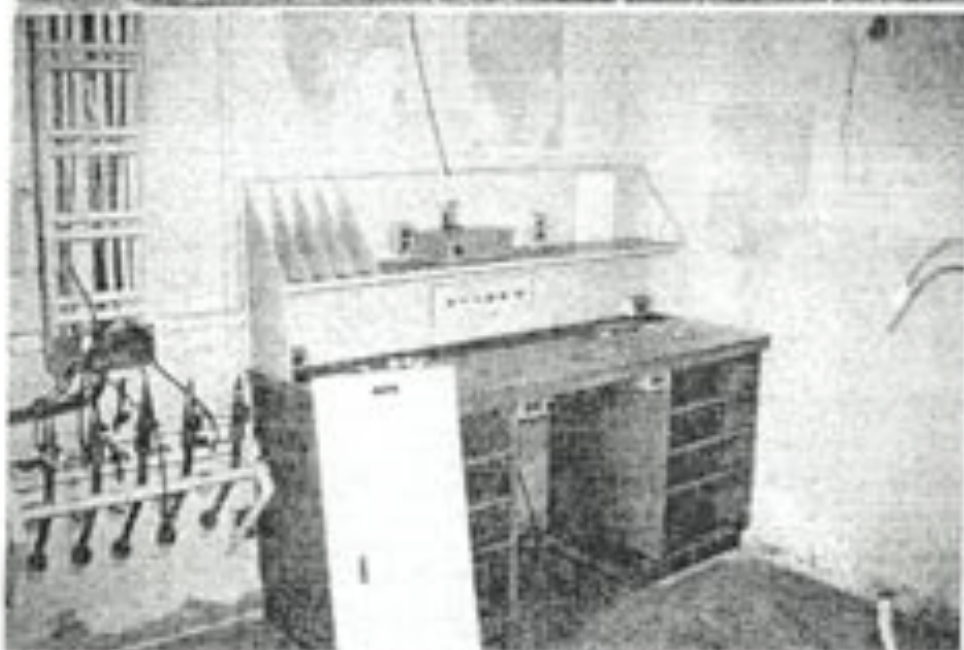
Building	The 25.8 SM reinforced concrete building remains on site.	The building's power generator was removed in July 95. A small number of electrical distribution panel remain. There is no asbestos, mercury or lead within this building which is an environmental concerns. No further action is considered necessary.
Communication Lines	A host of communication lines remain in the ground between the building and the antennae [ Note Annex B attached]. These cables have been left in the ground with most of the exposed cable removed.	The cable are not an environmental concern. However, depending on how the property is used, these cables may need removal by the future owner. No further action is considered necessary.
Service Road	A single lane road crossed the property connecting the building with the antennae yard.	The road remains in place and is not an environmental concern. No further action is considered necessary.

Bottom - Photo 4. Interior of building showing some of the equipment remaining. The auxiliary power unit was removed along with the day tank. No contaminants exist within building. (Photo taken 24 July 95).

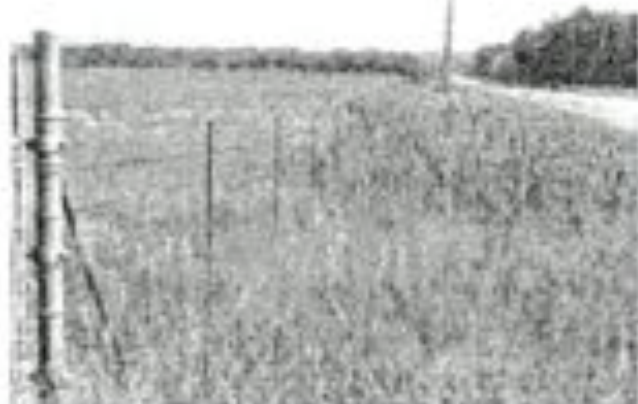
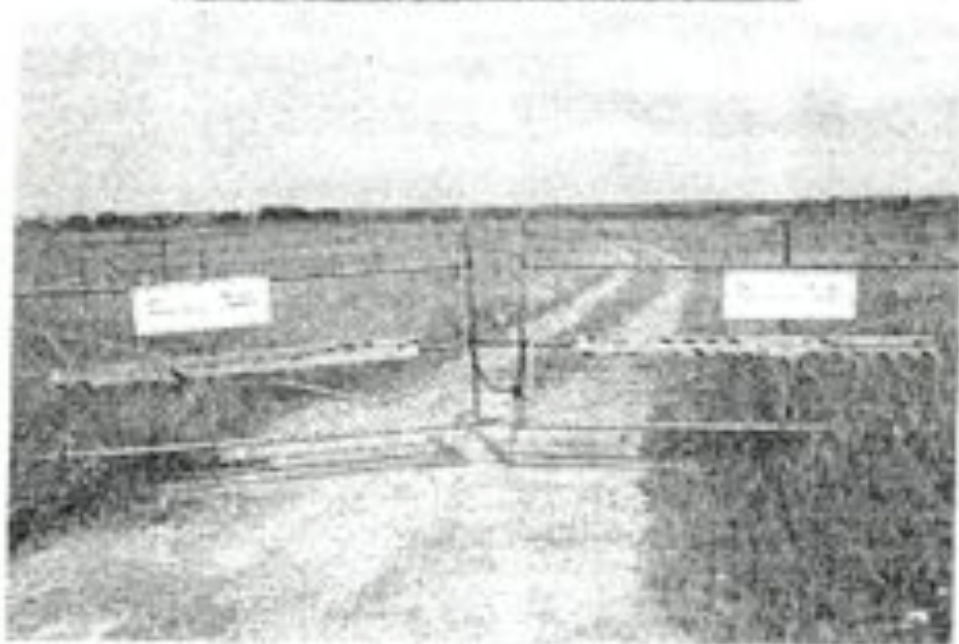
Gate and Fence	A gate exist on the entrance road. A seven strand barb wire fence with steel support posts surrounds a portion of the property.	The gate and fence are not an environmental concern. These will remain on site. No further action is necessary.

Photos 5 and 6. Photos of entrance gate and typical fencing that surrounds the property. (Photo taken 24 July 95).
